BUILDING REPORT

Report ref	BR-2026-004
Inspection	27 May 26
Inspector	Hubert Auld — Tillow Built Licence 393831C ABN 27 978 810 378
Status	Preliminary building report — indicative cost only, NOT a quote

1. SUMMARY

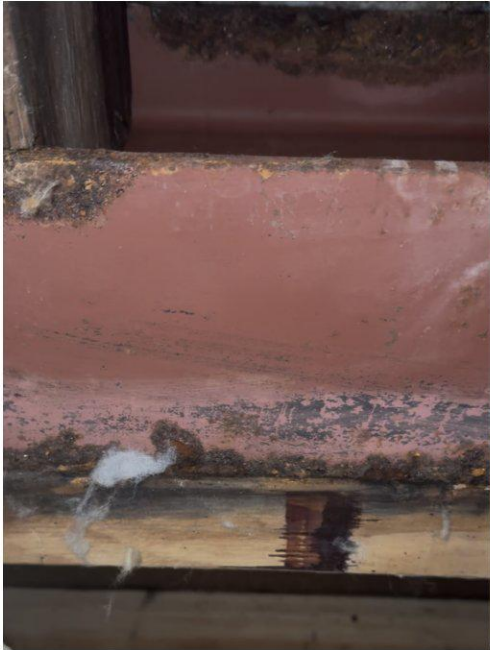
The painted steel beam (red oxide finish, likely original to the build) is corroded along its ENTIRE LENGTH. This is not a localised spot of damage — every accessible section of the beam shows active rust, scale build-up, paint failure, or moisture staining. Severity:

- Bottom flange: heavy scale and probable section loss (cannot be confirmed without ultrasonic thickness testing)
- Web (vertical sides): rust streaking, paint blistering, surface pitting
- Top surface: ongoing water exposure with mineral residue and salt efflorescence
- Beam embedment (wall pockets, both ends): visible corrosion at the bearing detail and efflorescence in adjacent masonry — water is tracking through the wall pocket
-

Photo 1 — Beam side view: rust scale along bottom flange and pitting on web

Tillow Built recommends engaging a structural engineer within seven days, commissioning an asbestos pre-demolition survey, and committing to a full remediation programme. An indicative cost range is provided in Section 7. A formal quotation will be issued once the engineer has confirmed the structural scope and the asbestos survey is complete.

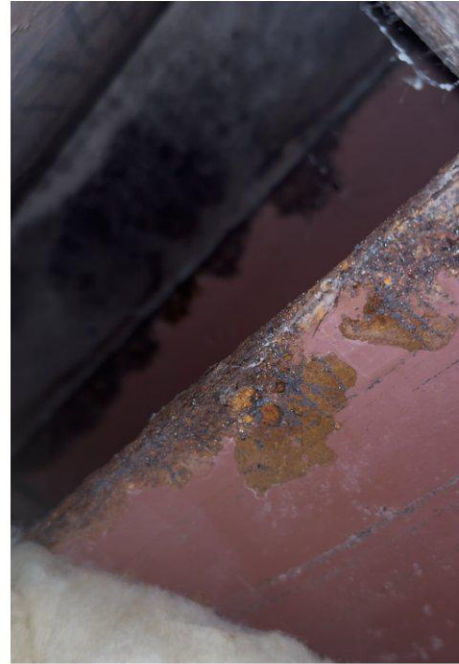
Photo 2 — Underside of beam: heavy scale and probable section loss

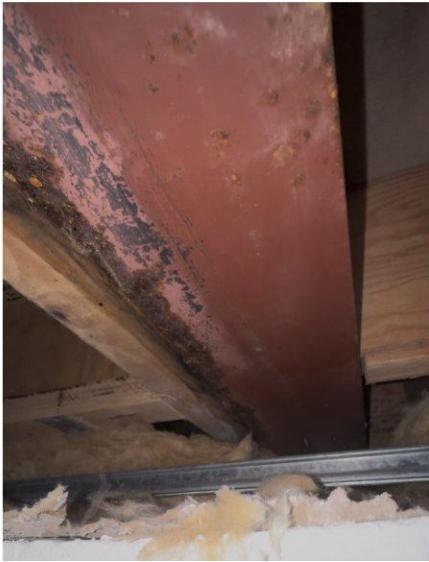
Photo 3 — Different angle of full length showing rust spread is not isolated

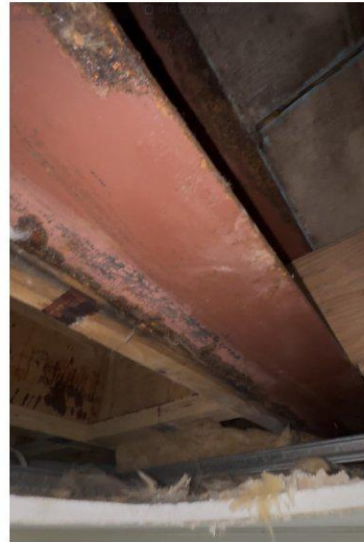
Photo 4 — Beam at wall junction: rust + adjacent timber moisture damage

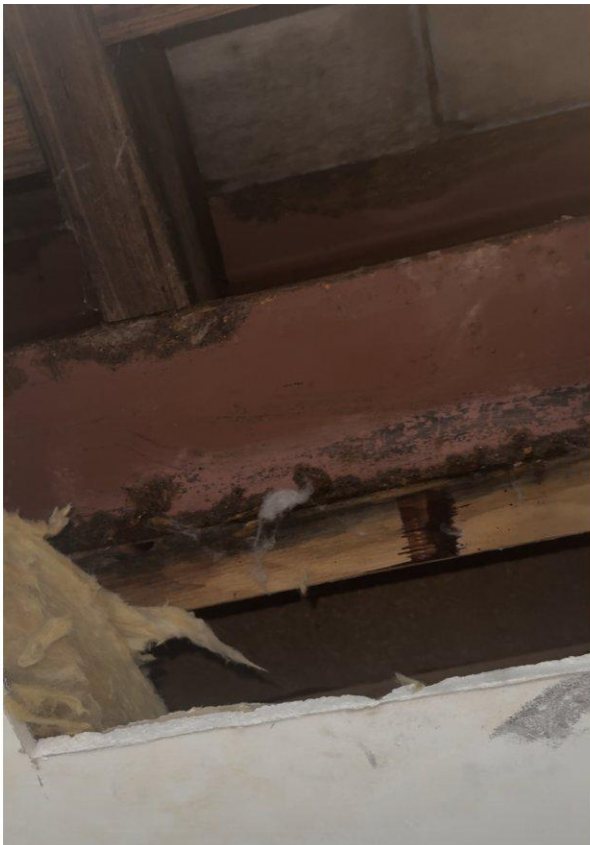
Photo 5 — Beam embedment at wall pocket: severe corrosion of bearing detail

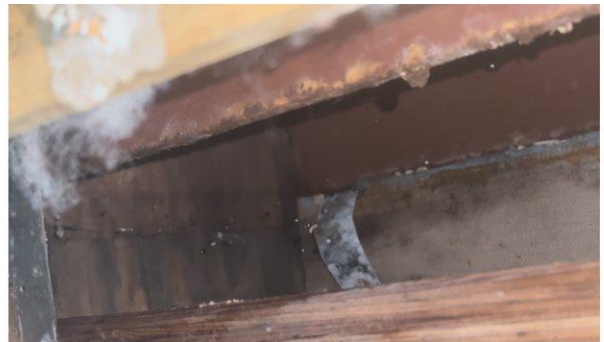
Photo 6 — Efflorescence visible in masonry adjacent to beam pocket

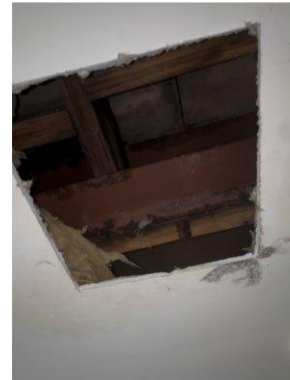
Visible mould growth and staining is present in the living room ceiling directly below the affected beam. This is consistent with IICRC S520 Condition 3 — visible growth on porous materials with active moisture source. Health-significant in an occupied dwelling.

Photo 8 — Second inspection opening — extent of cavity damage

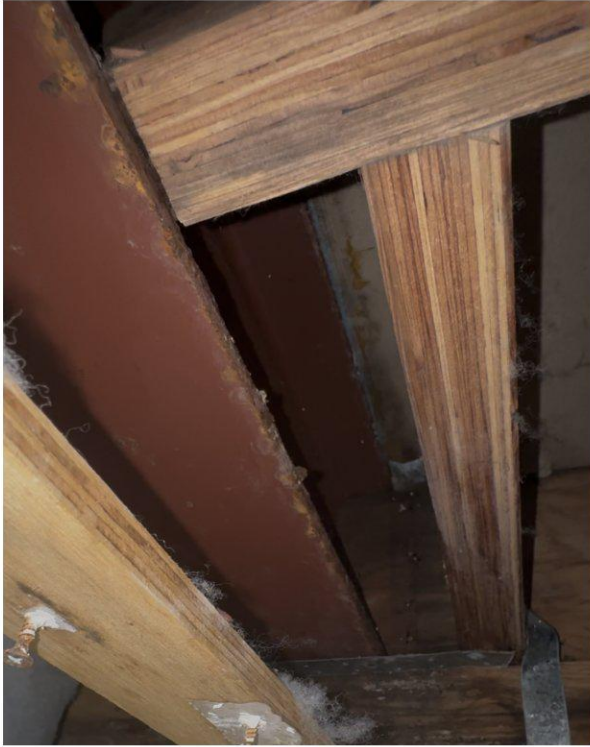
The timber joists, blocking, and wall plate adjacent to the beam show clear signs of moisture exposure. Some members will require splicing or replacement during remediation. Termite pest inspection is recommended — wet timber in Sydney inner suburbs is a high-risk termite environment.

Photo 9 — Joists and framing in cavity around beam

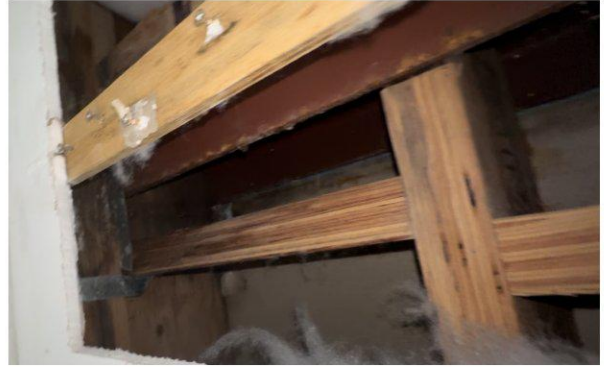
Photo 10 — Further framing detail showing moisture-affected timber

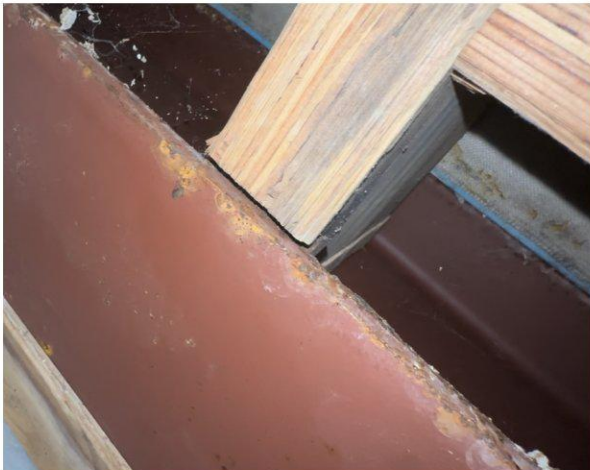
Cavity insulation visible in inspection openings is wet and contaminated. It cannot be dried and re-used — it must be removed under controlled conditions and replaced. Closed-cell insulation around the steel beam will be specified during reinstatement (standard batts will re-wet if any future moisture intrusion occurs).

Photo 11 — Wet insulation and joist-to-beam junction

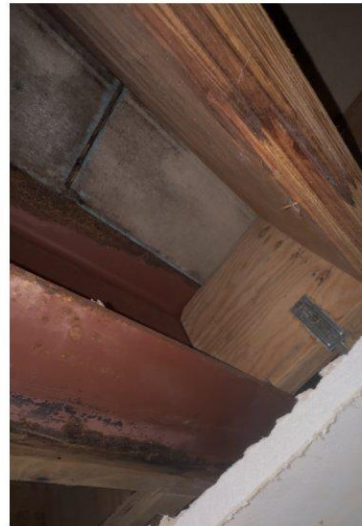
Photo 12 — Cavity view showing contaminated insulation and damp framing

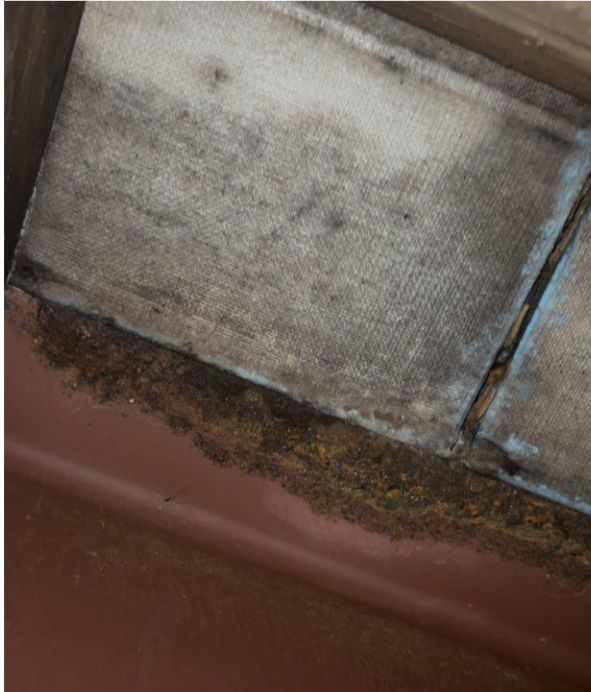
Where accessible, the interface between the failed membrane / deck substrate and the top of the steel beam shows heavy mineral residue, salt deposits, and rust streaking — visual confirmation that water has been ponding and tracking at this junction for an extended period.

Photo 13 — Beam top surface with mineral residue and corrosion

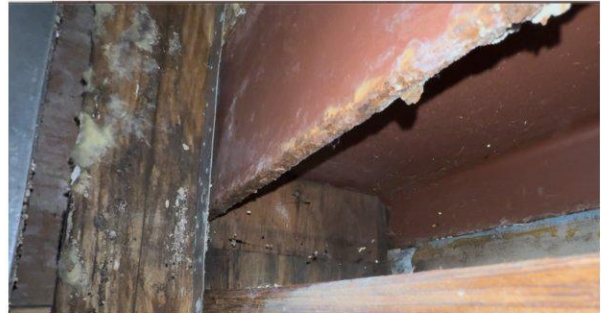
Photo 14 — Membrane substrate / beam junction with salt deposits

The full balcony build-up — tiles, bedding, screed, membrane — must be stripped and rebuilt. Spot repair of the membrane is NOT viable given the extent of leakage and the condition of the structural steel beneath.
